Analysis of Road Damage Factors Based on Vehicle Load and Volume on K.H. Zaenal Arifin Road Segment Cikulak – Cibogo

Nur Solahudin, Muhammad Daffa Putra Susanto

Universitas Swadaya Gunung Jati, Cirebon, Indonesia

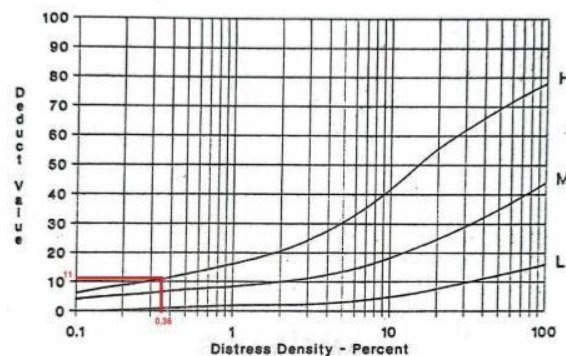
1. Weathering

$$\begin{aligned}
 \text{Density (Density) (\%)} &= \frac{AdA}{A} \times 100 \\
 &= \frac{64,8593}{18000} \times 100 \\
 &= 0,360 \%
 \end{aligned}$$

Figure 1. DV results of weathering pavement damage

When using fine aggregates, compacted with a light compactor. Furthermore, for handling hole damage and weathering is patching, patching can be done with the following steps, namely: 83

1. Make a square mark on the area to be treated with paint or chalk.
2. Dig the road layer in the area that has been marked with a square, until it reaches a solid layer.
3. Compacting the excavation base.
4. Fill the excavation pit with substitute materials (aggregate foundation coating material or cold asphalt mixture).
5. Compacting layer by layer.

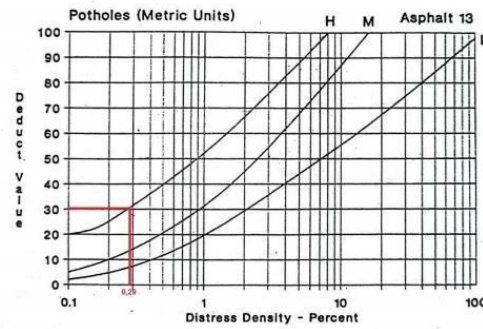
2. Lubang

$$\begin{aligned}
 \text{Density (Density) (\%)} &= \frac{AdA}{A} \times 100 \\
 &= \frac{52,9811}{18000} \times 100 \\
 &= 0,294 \%
 \end{aligned}$$

Figure 2. DV results of pit pavement damage

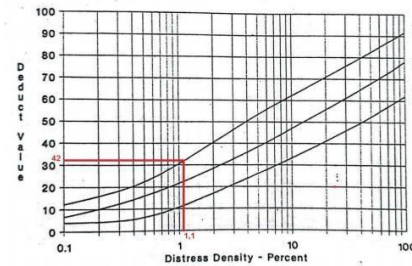
3. Crocodile crack

$$\begin{aligned}
 \text{Density (Density) (\%)} &= \frac{AdA}{A} \times 100 \\
 &= \frac{209,1051}{18000} \times 100 \\
 &= 1,162 \%
 \end{aligned}$$

Figure 3. DV results of crocodile cracked pavement damage

In the case of alligator skin cracking, the treatment steps are:

1. Cleaning the part to be handled.
2. Marking the area to be treated squarely.
3. Spray 1.5 kg/m² emulsion asphalt on the marked part until evenly distributed.
4. Spread coarse sand or fine, flattened aggregate.

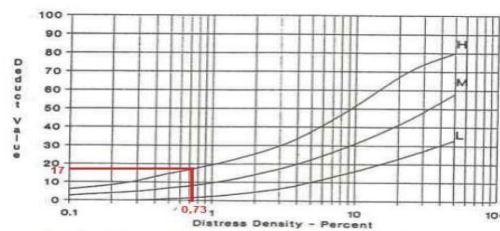
4. Tambalan

$$\begin{aligned}
 \text{Density (Density) (\%)} &= \frac{AdA}{A} \times 100 \\
 &= \frac{132,3318}{18000} \times 100 \\
 &= 0,735 \%
 \end{aligned}$$

Figure 4. Results of DV damage to the pavement patch

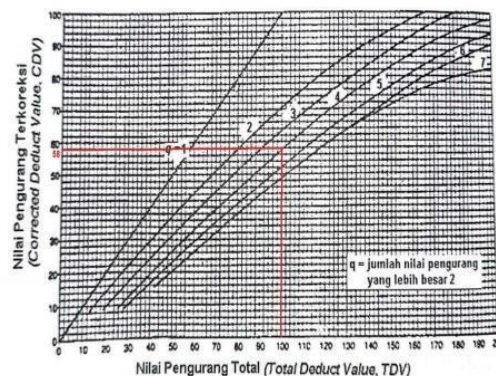
To determine the total deduction value, draw a vertical draw according to q (the number of deduction values greater than 2 because the research area uses pavement with an asphalt surface), draw a horizontal line to the left, and the corrected deduction value of 58 can be seen in **Figure 5**.

Figure 5. Graph of CDV calculation results

$$\begin{aligned}
 &= 100 - \text{CDV} \\
 &= 100 - 58 \\
 &= 42
 \end{aligned}$$

So, the PCI value is on the KH road. Zaenal Arifin Cikulak- Cibogo is 42 with a moderate (fair) condition value.

occurs on the section of Jalan Zaenal Arifin, it can be determined that the standard repair method that can be carried out according to the practical instructions for routine maintenance of the UPR.02.1 of 1992 of the Director General of Highways, namely Handling Method 2 (P2) Local Asphalt Planting (*Local Sealing*), Handling Method 5 (P5) Patching, Handling Method 6 (P6) *Leveling*. And for the thickness of the overlay with a CESA value of 2,920,973, the thickness of the overlay required is 7 cm (AC–WC = 4cm; AC – BC = 3 cm).
