BIO-CORROSION PHENOMENON OF TITANIUM GRADE 2 TUBES IN CONDENSER OF A STEAM POWER PLANT

Yuni Eko Feriyanto, Zulfikar Surya Putra, Nia Ariningtyas, Sandro Sitohang

PT Pembangkitan Jawa Bali Services, Indonesia

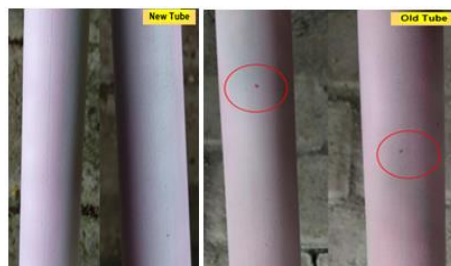
The test was carried out using a special liquid that penetrates within the surface defect and is visually projected to its surface. Based on Fig. 3, the new tube showed zero-defect but on the contrary, the old tube showed red spots which indicate a leak which is indicated as pitting corrosion.

Figure 3. Penetrant test, surface of the new and old tube.

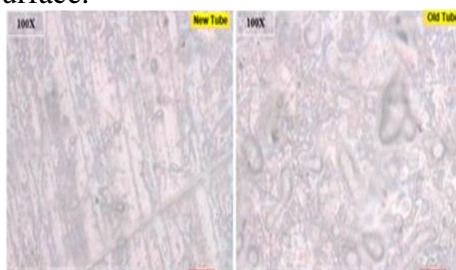
Micro-spectrograph of tube surface was performed with the Olympus U-TV0.5XC-3 tool. Based as shown in Fig. 10, the old tube has a rougher surface compared to a new tube which indicated a corroded surface.

Figure 9. Micro spectrograph test, surface of the new and old tube
