# STUDY OF THE IMPACT OF COASTLINE CHANGES ON COASTAL SETTLEMENT AREAS ALONG TH EAST COAST OF MINAHASA

Warouw Fela<sup>1</sup>, Rondonuwu Dwight<sup>2</sup>, Sondakh Julianus<sup>3</sup> <sup>1,2,3</sup> Department of Architecture, Faculty of Engineering, Sam Ratulangi University, Indonesia

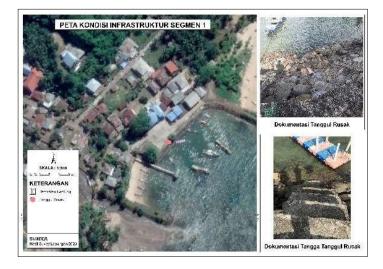
Figure 9. Dusun 1 Desa Atep Oki

Atep Oki Village consists of two hamlets separated by a water body in the form of the Atep Oki River. In the 'dusun satu'(1) there is an infrastructure of breakwater dikes and ship demaga as part of the Fish Auction Site facility (2013) built by the Public Works Office. In 2023 observations, it was found that there was medium damage to the breakwater embankment due to tidal waves (figure 9). Beach retreat is not found in this area, and the building area is on

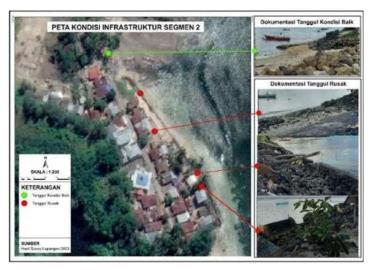
Figure 10. Dusun 2 Desa Atep Oki

land so there is no damage. In contrast to 'dusun dua' (2) which suffered damage to road infrastructure and land retaining talud built independently by the community (figure 10). Severe damage was suffered to houses on the coast, where parts of the house were destroyed when the tidal wave damaged the retaining talud of the land where the houses were located (table 9).
